Windstorm Mitigation Report (OIR-B1-1802)

Park Lake At Parsons Condominium Association, Inc.

Building 13, 221 Lake Brook Cir, Units 101-208

As of 5/11/2021 | FPAT File# REN2115913

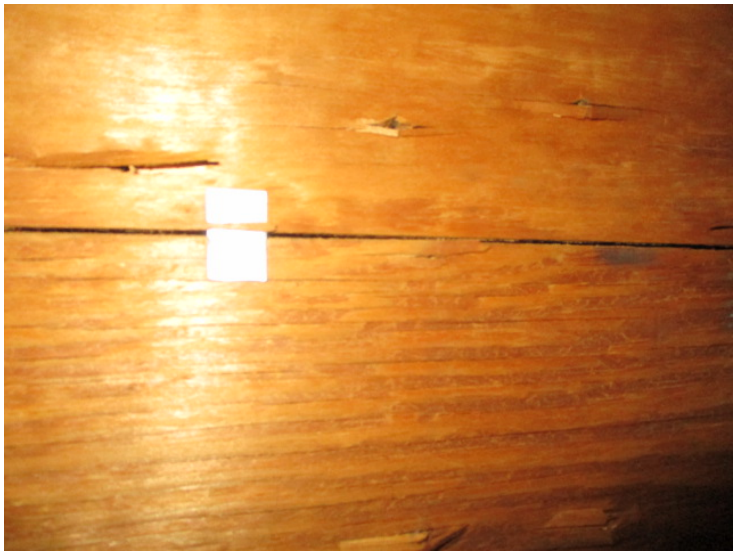
Roof Construction

3.	**Roof Deck Attachment:**	**Level C**
	Comments:	Inspection verified 1/2" plywood roof deck attached with 8d nails at a minimum 6" on the edge & 6" in the field.

4.	**Roof to Wall Attachment:**	**Clips**
	Comments:	Inspection verified hurricane clips fastened with a minimum of three nails.
5.	**Roof Geometry:**	**Other Roof**
	Comments:	Inspection verified a gable roof shape.
