# Windstorm Mitigation Report (OIR-B1-1802)

Park Lake At Parsons Condominium Association, Inc.

Building 9, 305 Lake Parsons Green, Units 101-104

As of 5/11/2021 | FPAT File# REN2115913

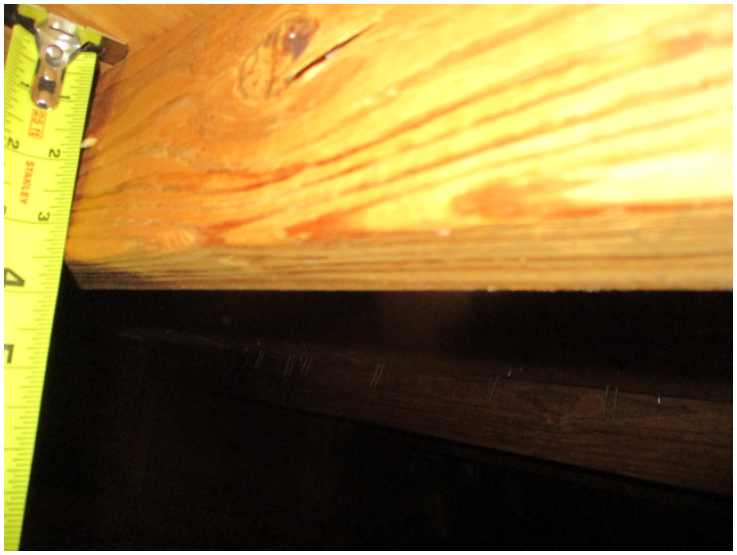
Roof Construction

3. **Roof Deck Attachment:** **Level C**
   Comments: Inspection verified 1/2" plywood roof deck attached with 8d nails at a minimum 6" on the edge & 6" in the field.

4. **Roof to Wall Attachment:** **Clips**
   Comments: Inspection verified hurricane clips fastened with a minimum of three nails.
