Windstorm Mitigation Report (OIR-B1-1802)

Park Lake At Parsons Condominium Association, Inc.

Building 7, 308 Lake Parsons Green, Units 101-208

As of 5/11/2021 | FPAT File# REN2115913

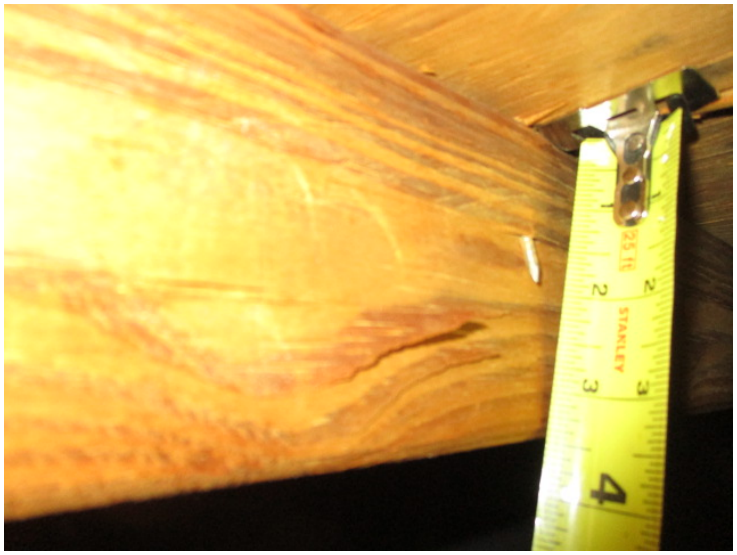
Roof Construction

3. **Roof Deck Attachment:** **Level C**
   Comments: Inspection verified 1/2" plywood roof deck attached with 8d nails at a minimum 6" on the edge & 6" in the field.

4. **Roof to Wall Attachment:** **Clips**
   Comments: Inspection verified hurricane clips fastened with a minimum of three nails.
