Windstorm Mitigation Report (OIR-B1-1802)

Park Lake At Parsons Condominium Association, Inc.

Building 2, 703 Parsons Lake Path, Units 101-208

As of 5/11/2021 | FPAT File# REN2115913

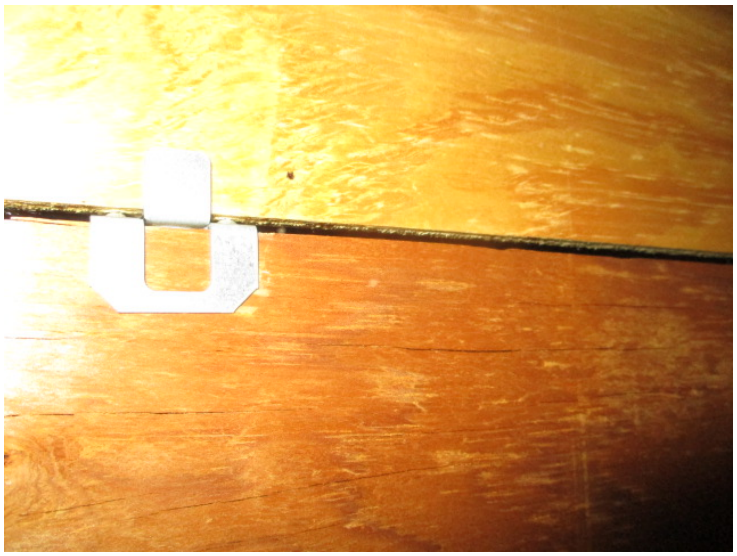
Roof Construction

3.	**Roof Deck Attachment:**	**Level C**
	Comments:	Inspection verified 1/2" plywood roof deck attached with 8d nails at a minimum 6" on the edge & 6" in the field.

4.	**Roof to Wall Attachment:**	**Clips**
	Comments:	Inspection verified hurricane clips fastened with a minimum of three nails.
5.	**Roof Geometry:**	**Other Roof**
	Comments:	Inspection verified a gable roof shape.
